Facility Assessment

Sonora ISD

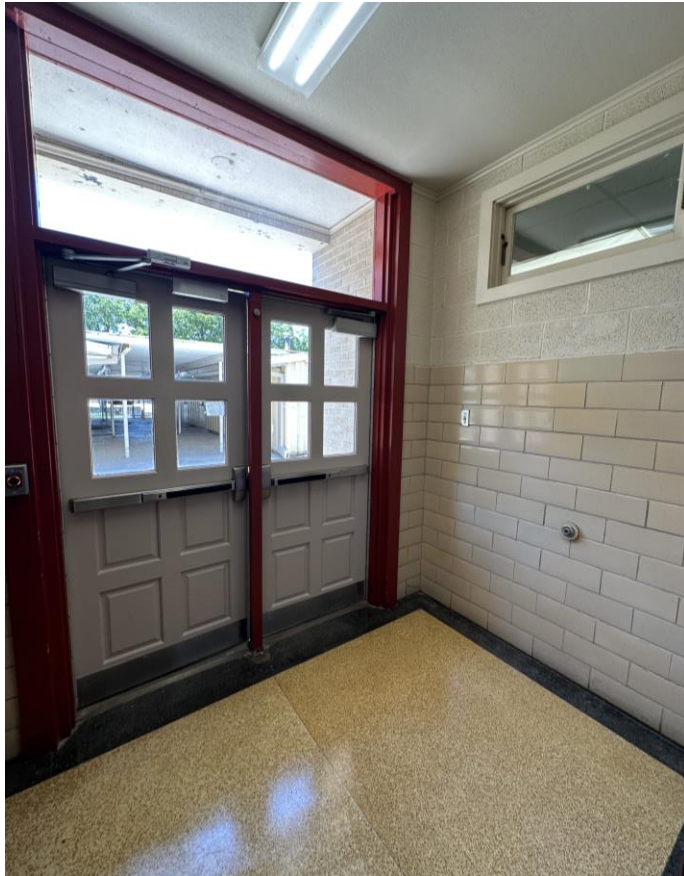
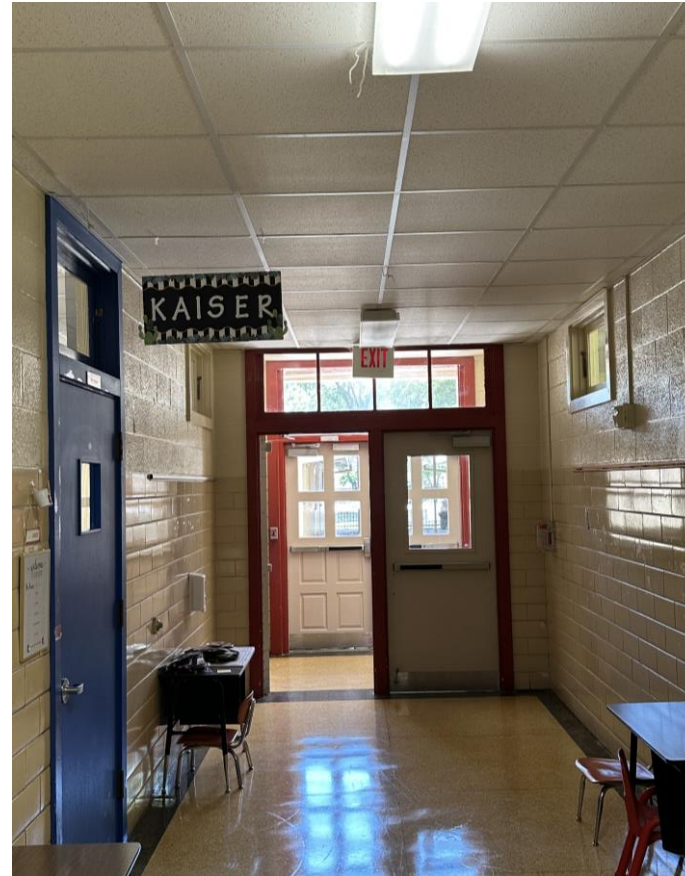
Evidence of Structural Movement

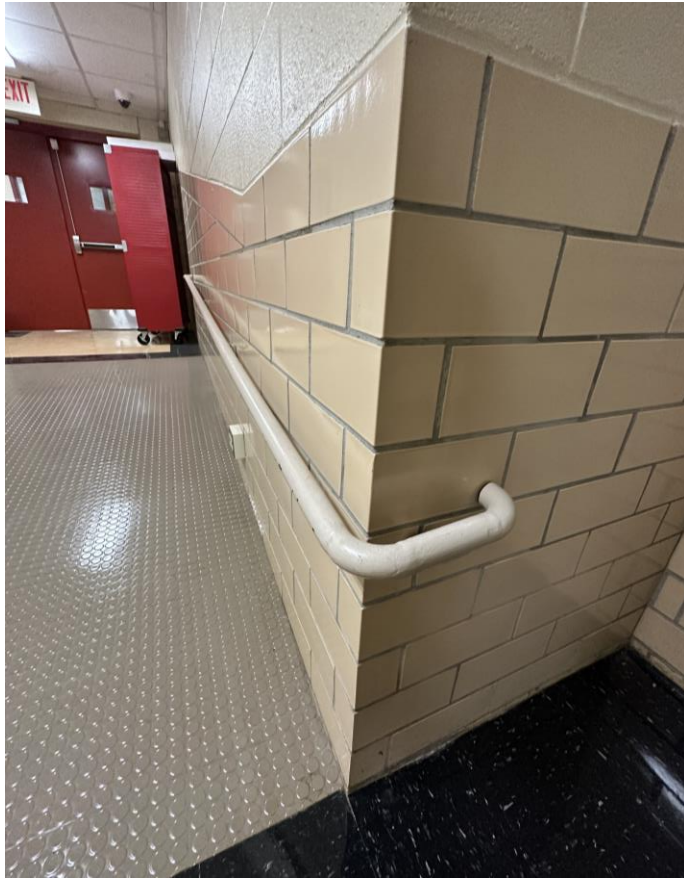
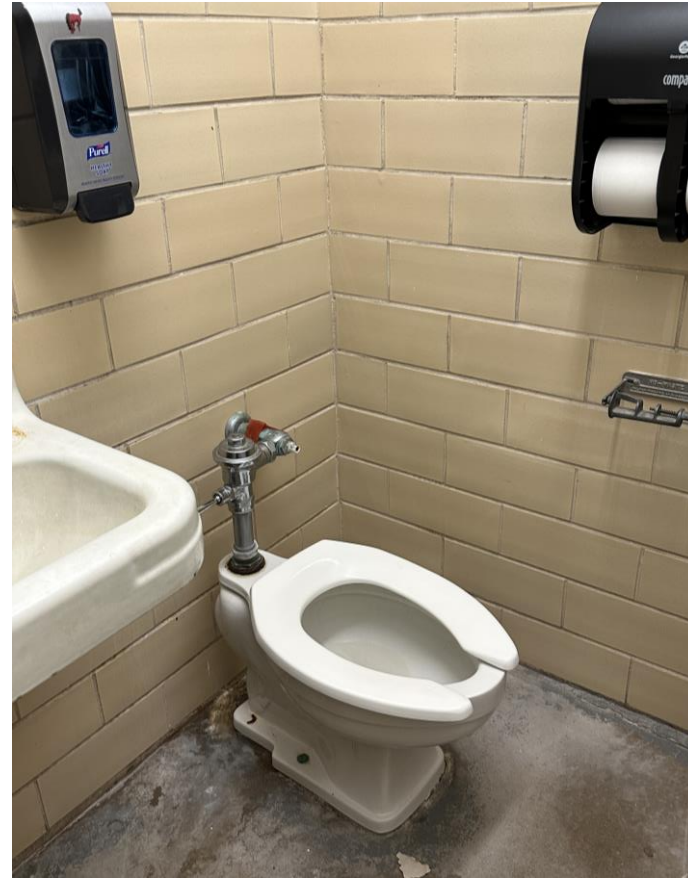
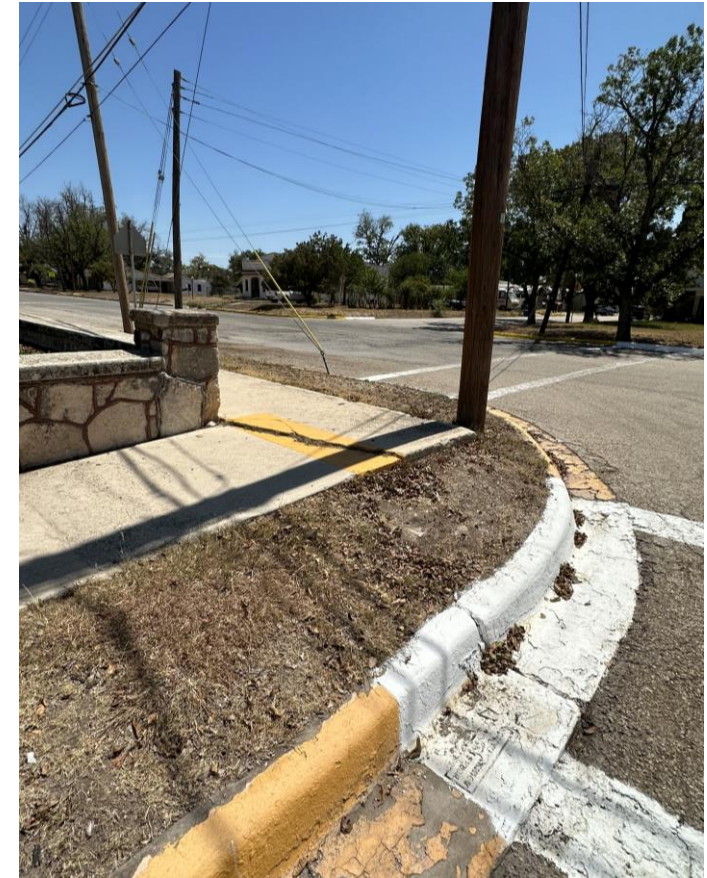
TAS/ADA

- Upgrade restrooms including all door hardware to meet current TAS/ADA requirements.
- Address fire risk issues in all electrical closets, classrooms, and corridors.
- Replace aging HVAC units to improve energy efficiency rating and avoid failure.*
- Add a protective awning near the drop-off area.
- Renovate and upgrade kitchen equipment and interior spaces.
- Update furniture
- Add backup generator
- Add keycard access to interior doors

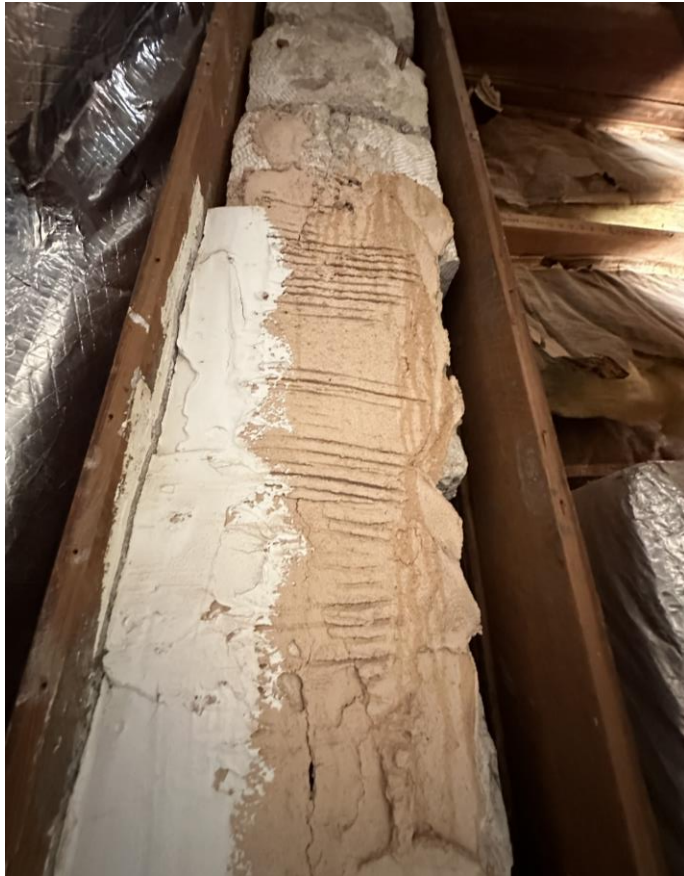
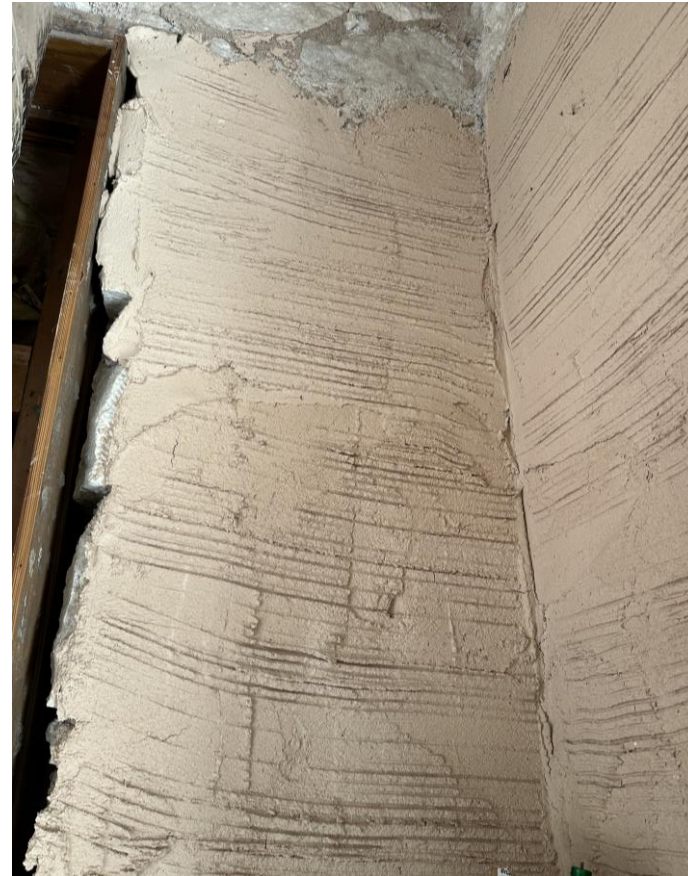
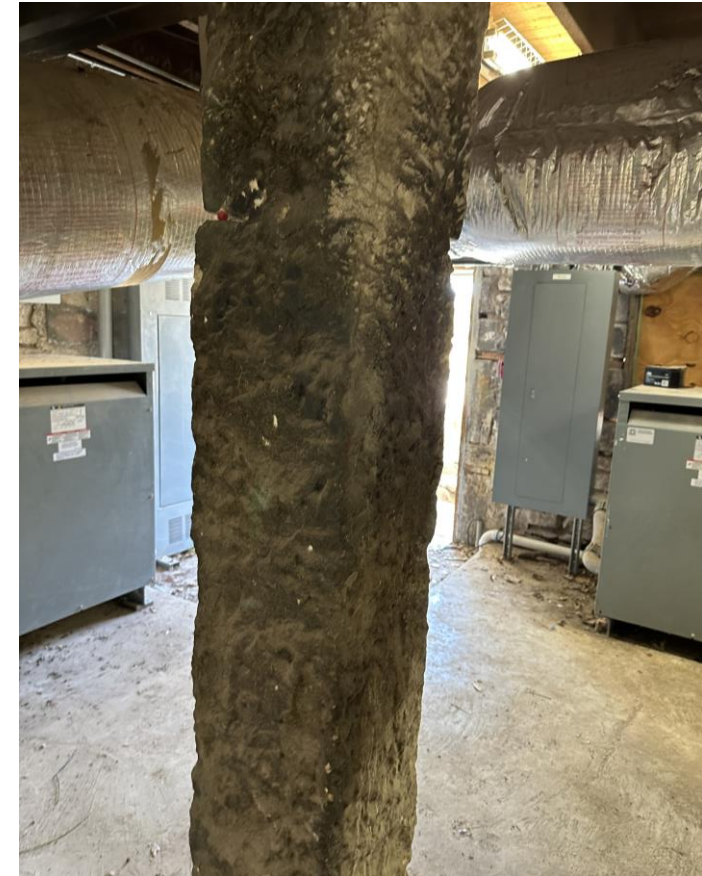
Structural Risk

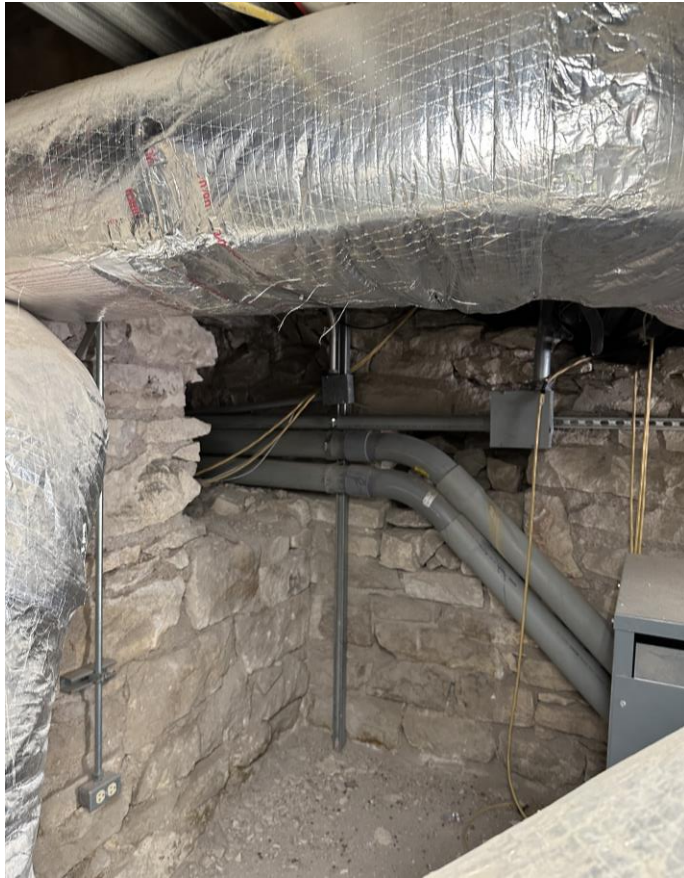
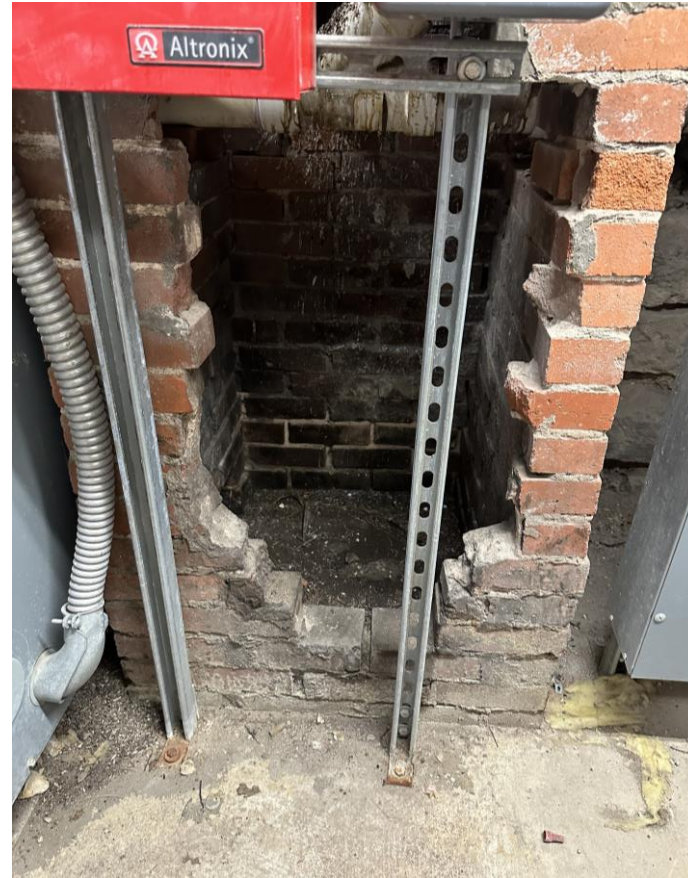
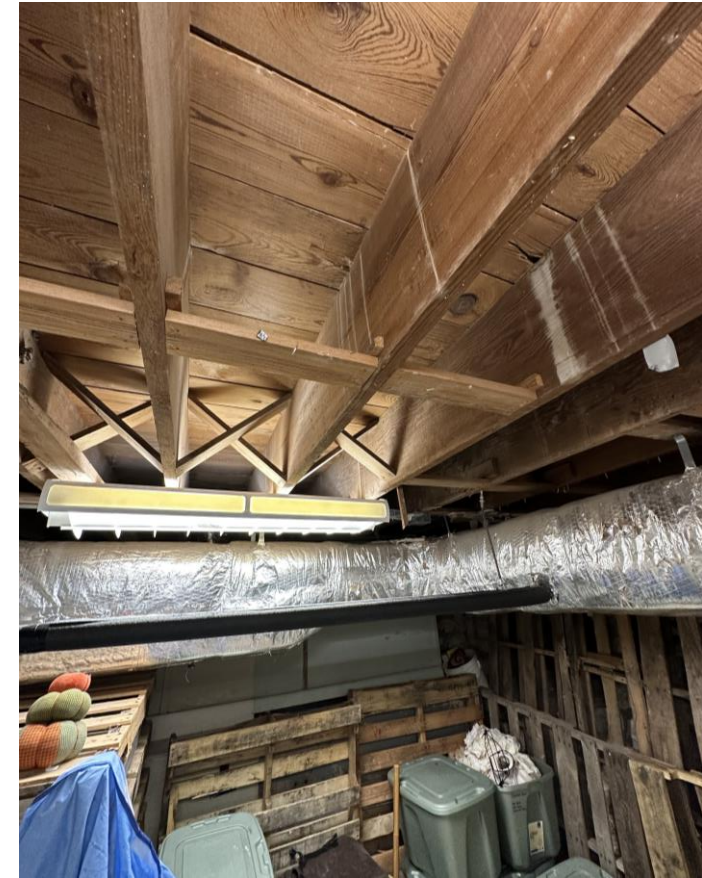
Fire Risk

- Upgrade restrooms including all door hardware to meet current TAS/ADA requirements.
- Address fire risk issues in all electrical closets, classrooms, and corridors.
- Replace aging HVAC units to improve energy efficiency rating and avoid failure.*
- Upgrade finishes in each classroom for walls and floor surfaces.
- Add a protective awning near the drop-off area.
- Update furniture
- Add a backup generator
- Add keycard access to interior doors

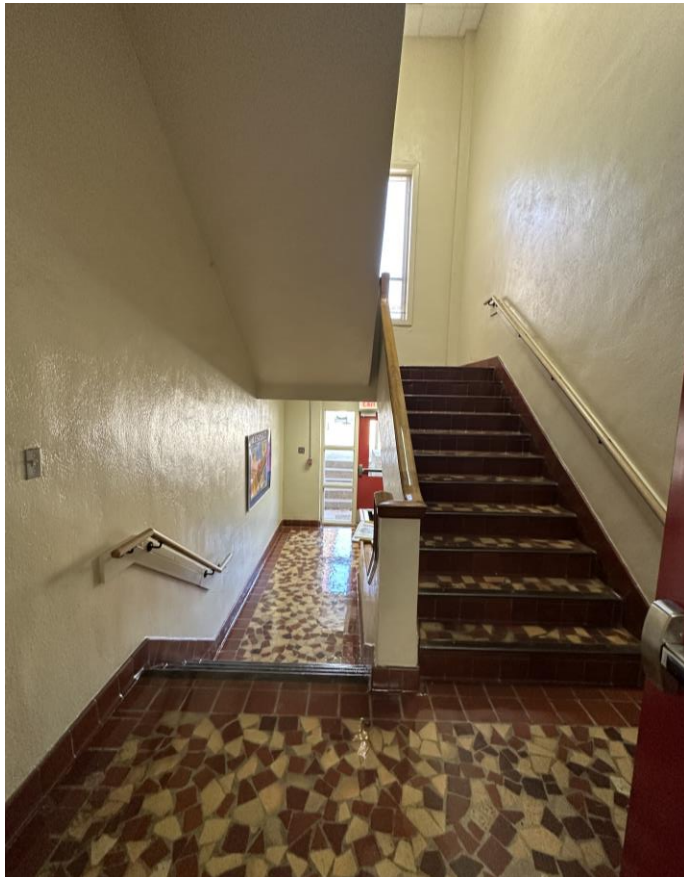
Does not meet TAS/ADA requirements

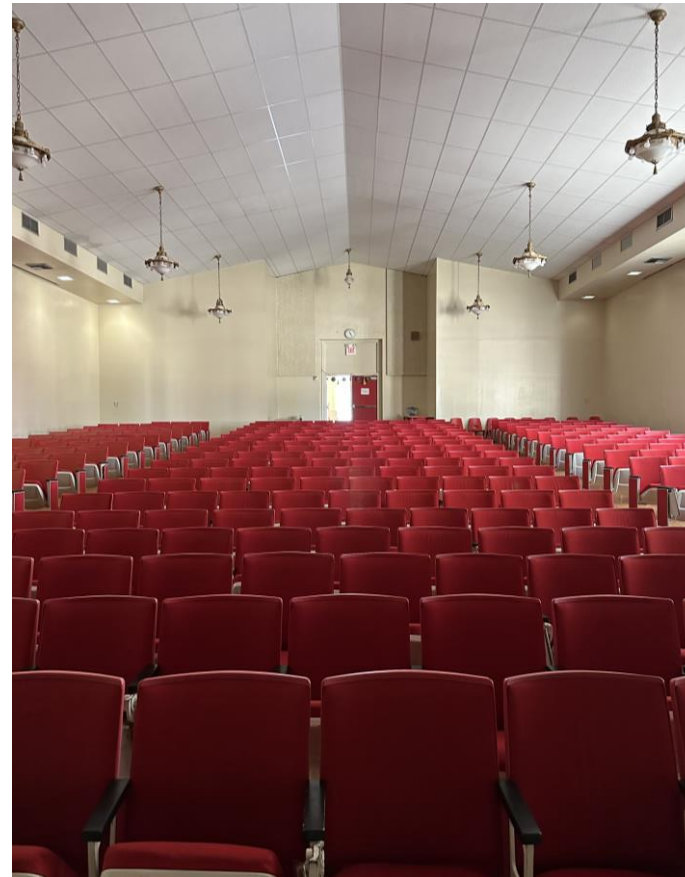
Needs a secure foyer

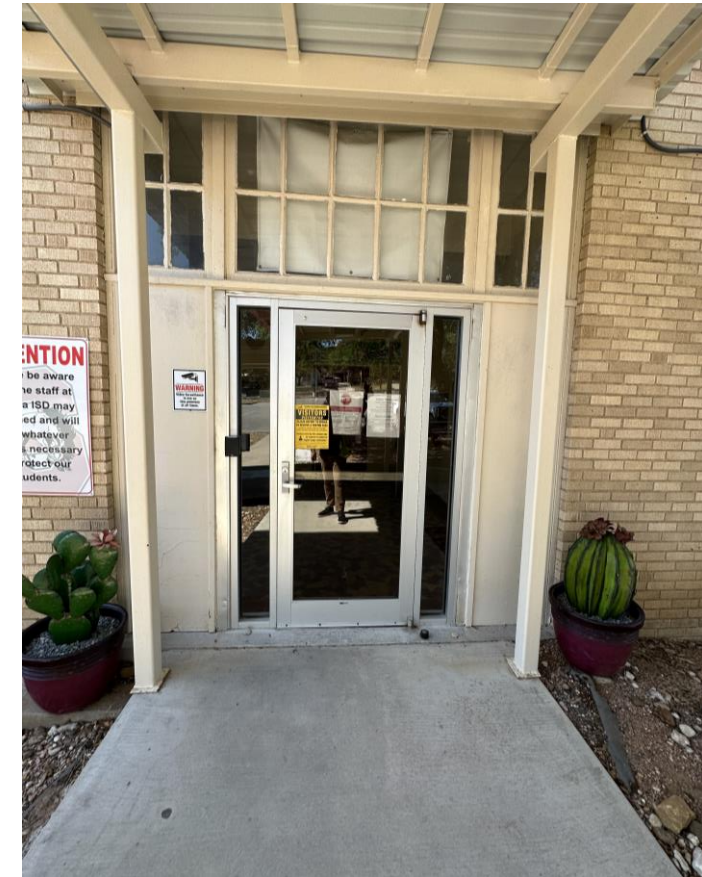
Inadequate lighting

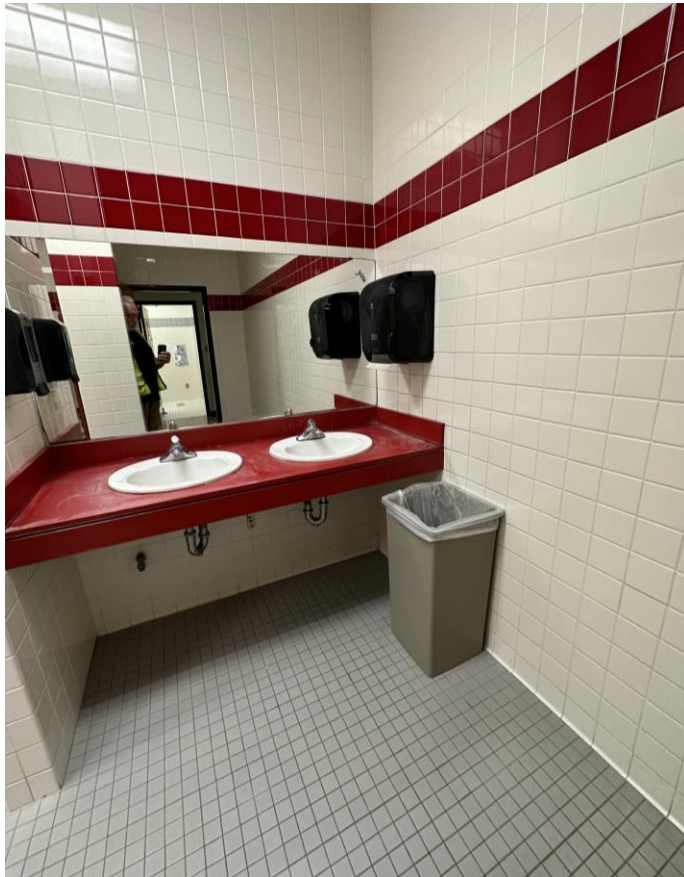
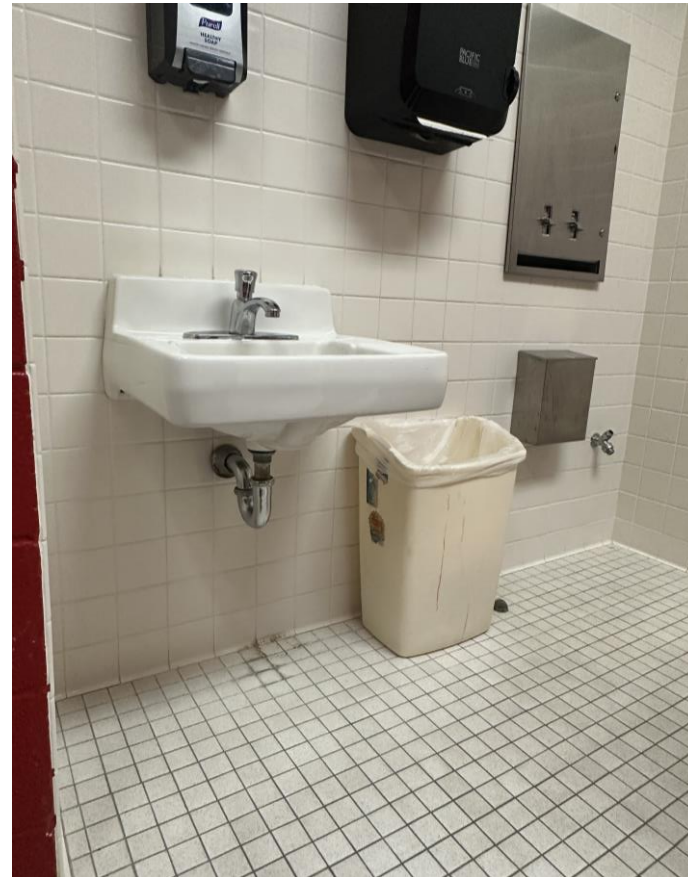
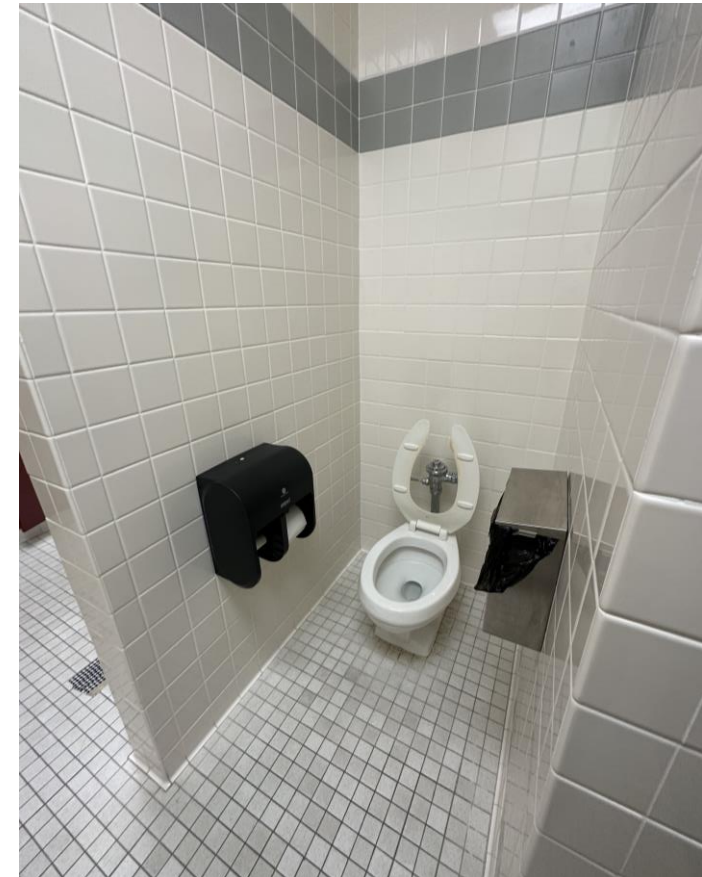
TAS/ADA

- Repave all asphalt parking lots and repaint all pavement markings
- Install crosswalks to improve safety
- Replace carpet in all areas
- Repaint all interior classrooms and corridors
- Replace hardware and restroom partitions
- Upgrade restrooms to meet current TAS/ADA requirements
- Upgrade lighting in the auditorium
- Increase parking lot capacity

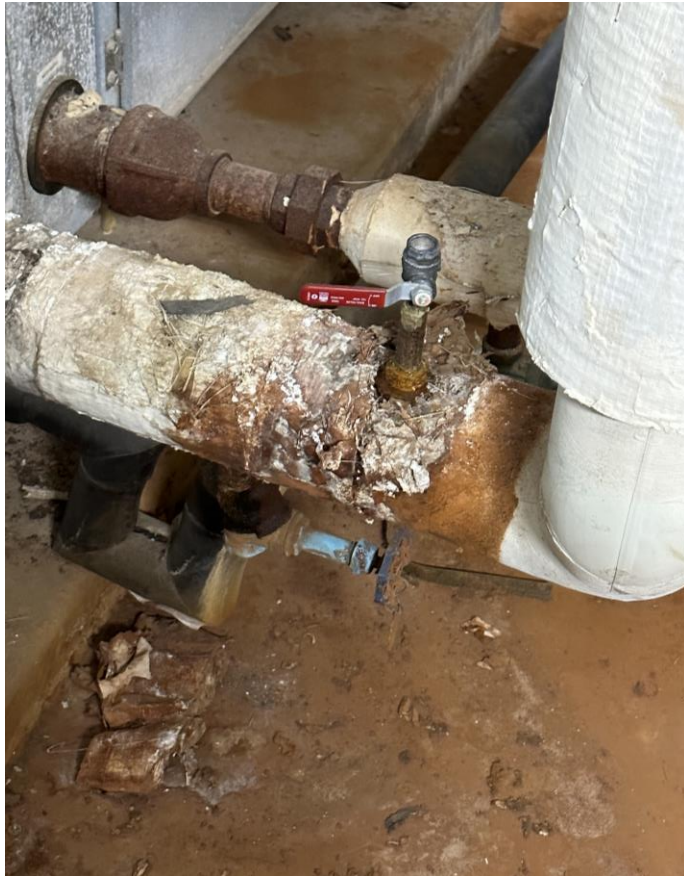
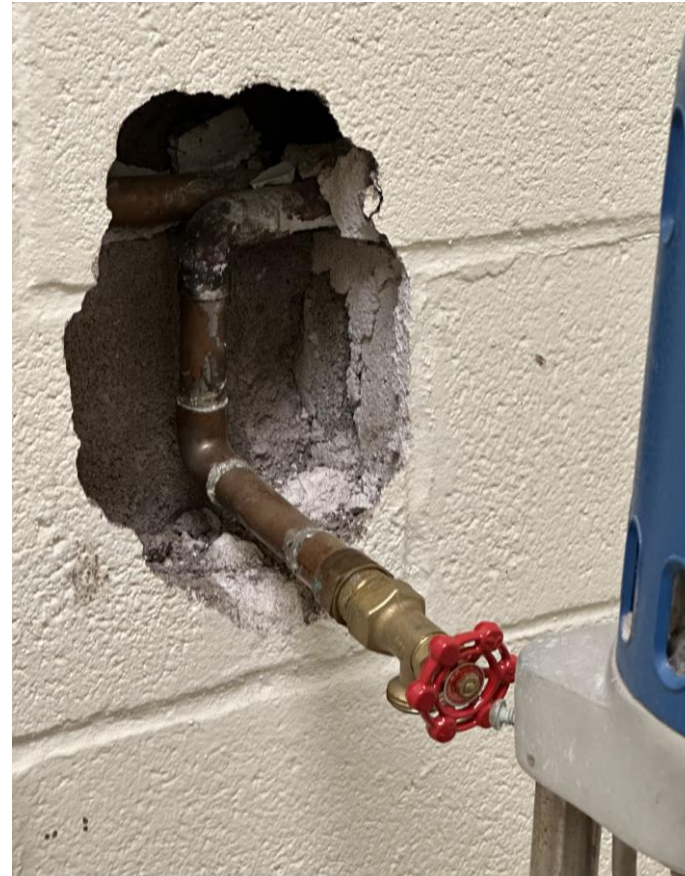
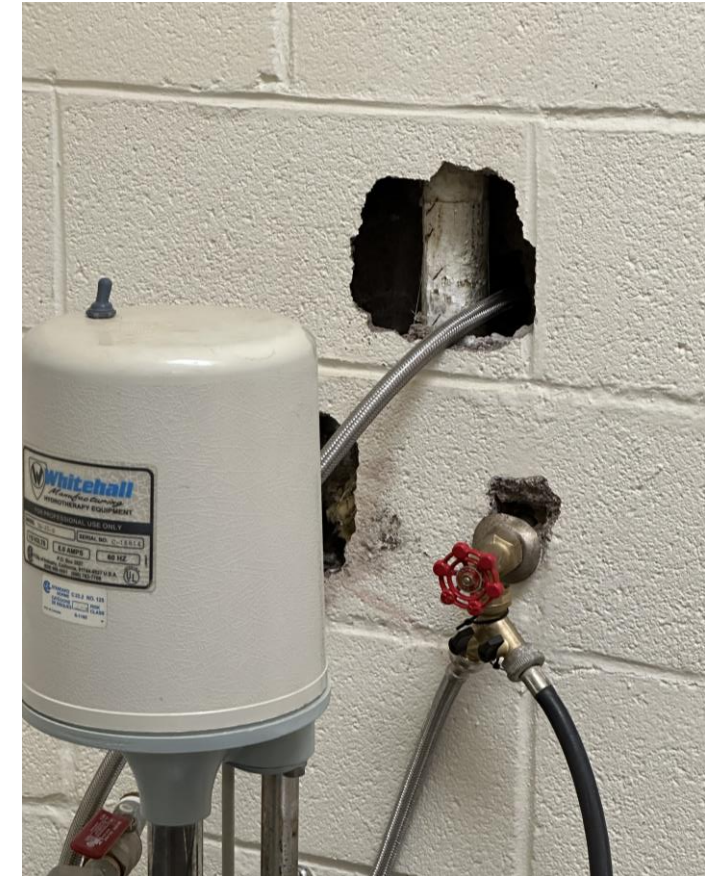
Inadequate Plumbing

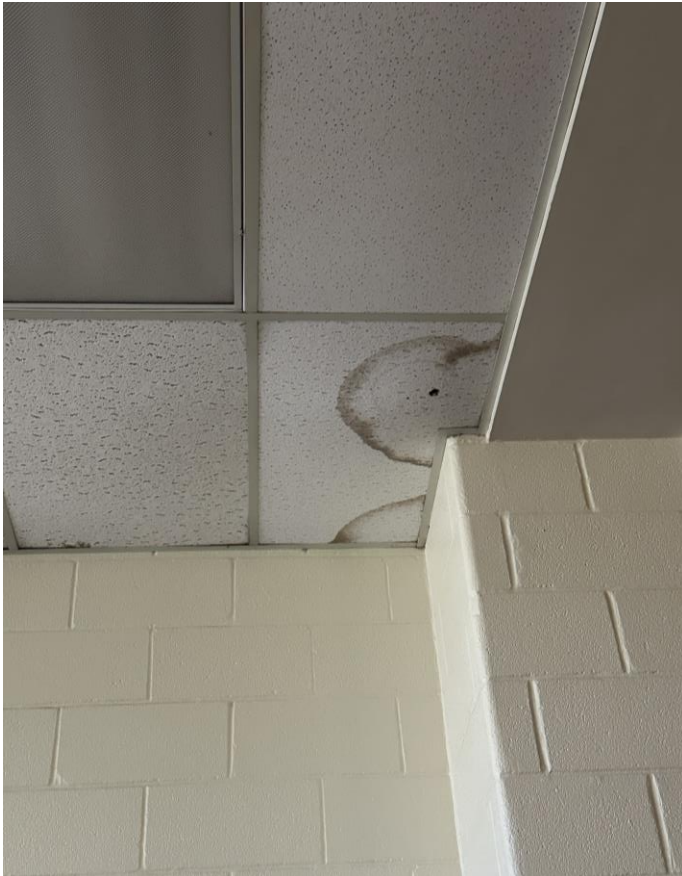
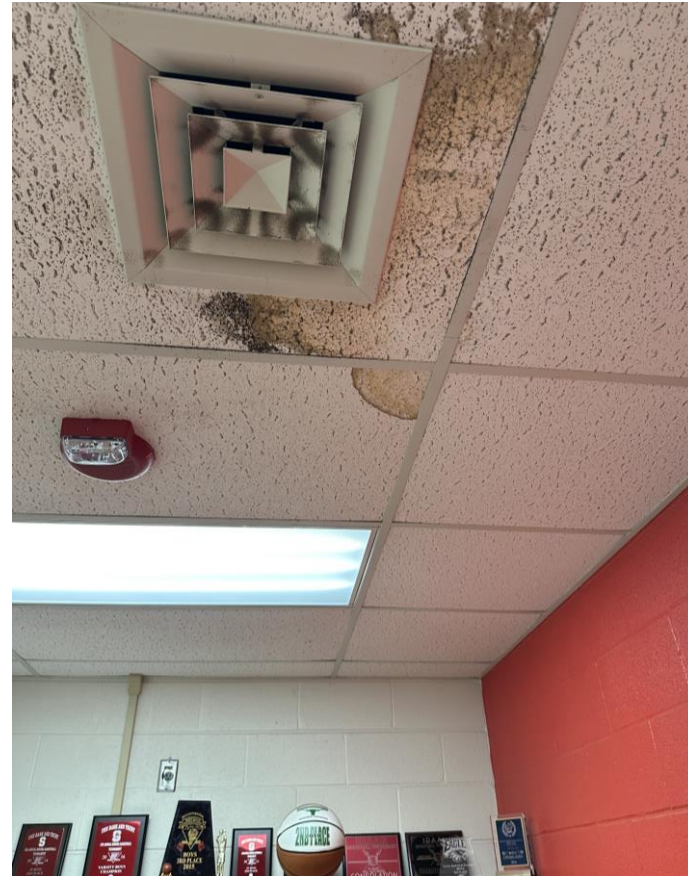
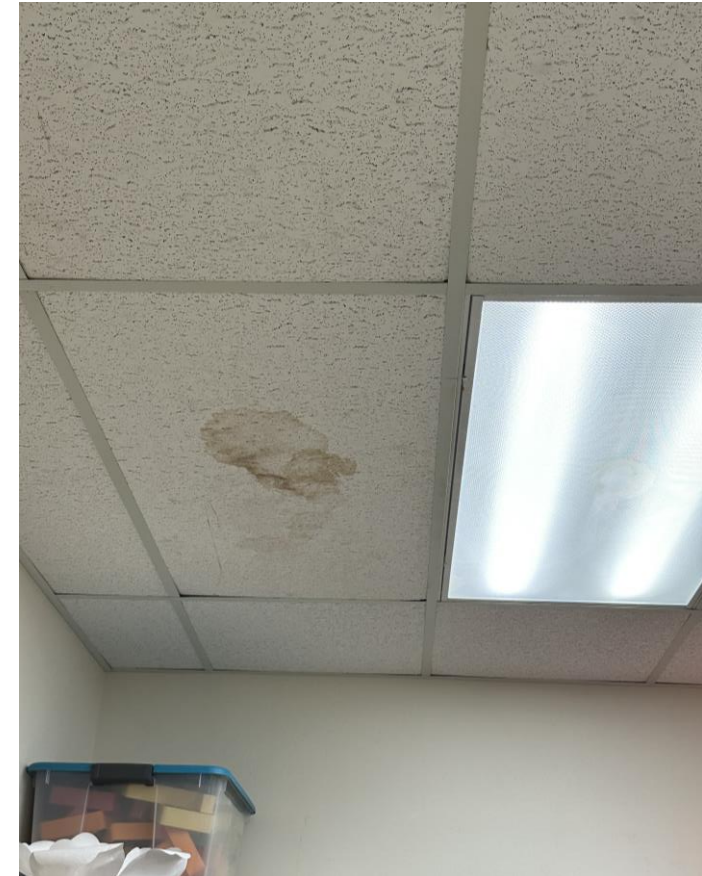
Evidence of Moisture Damage

- Define visitor parking spaces
- Replace aging HVAC units to improve energy efficiency rating and avoid failure.*
- Add outdoor PE area for 7th & 8th grades
- Add moisture barrier / correct moisture barrier at HS commons
- Add keycard access to interior doors
- Convert HS locker areas to commons
- Inadequate electrical
- Backup power (computer closets)

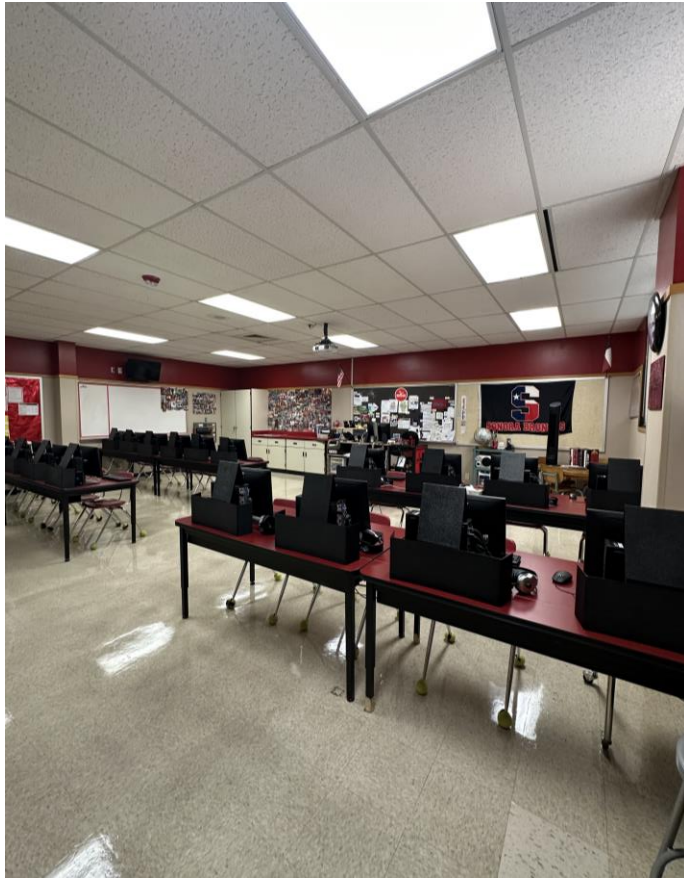
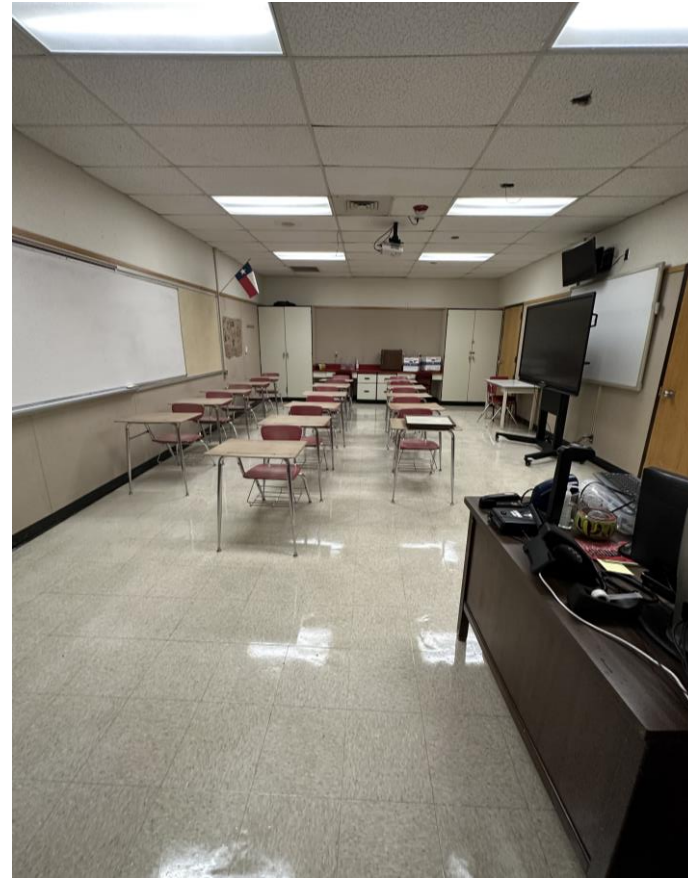
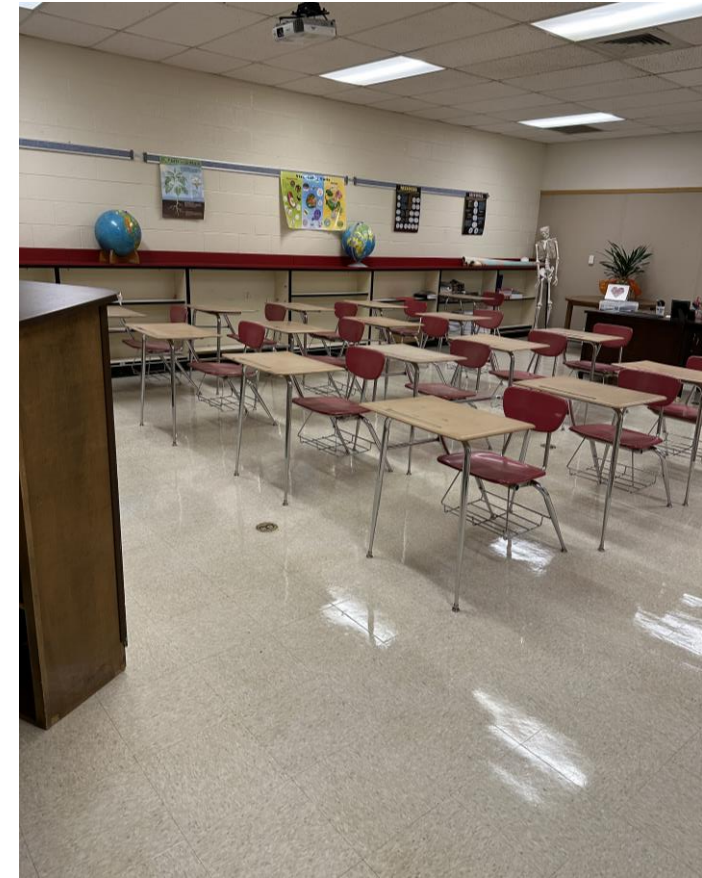
Undersized Classrooms

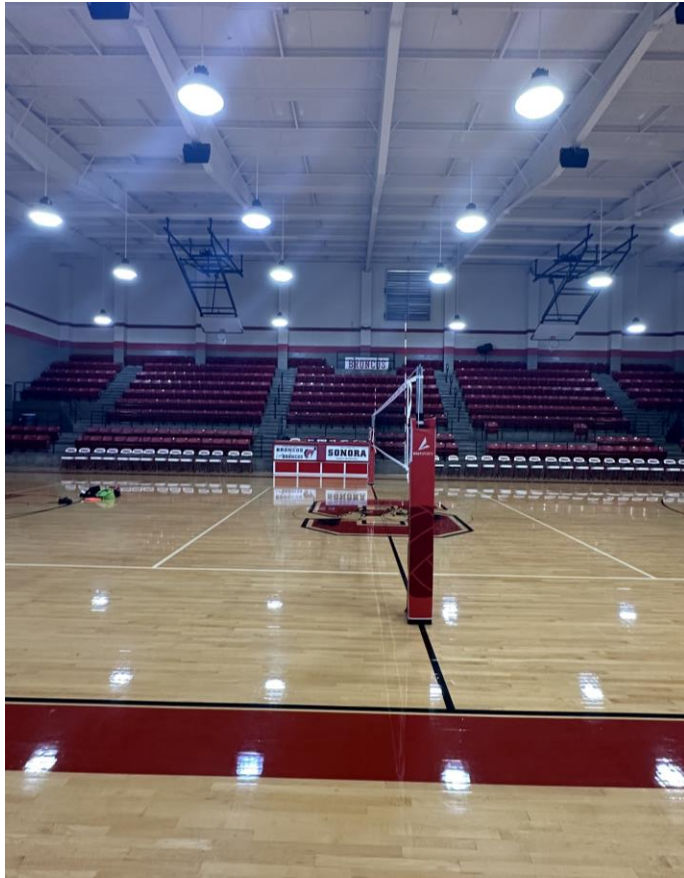
- The lighting in the gymnasium needs to be upgraded. Continue to maintain the athletic fields to be in premium condition.

Inadequate lighting

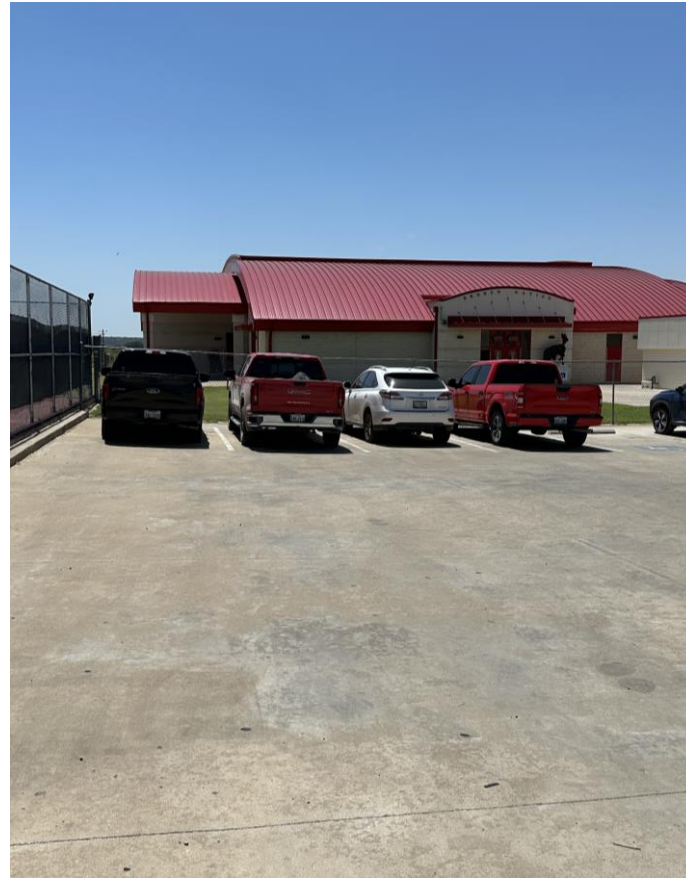
Needs pavement marking for fire lane
