Facility Assessment

Sonora ISD

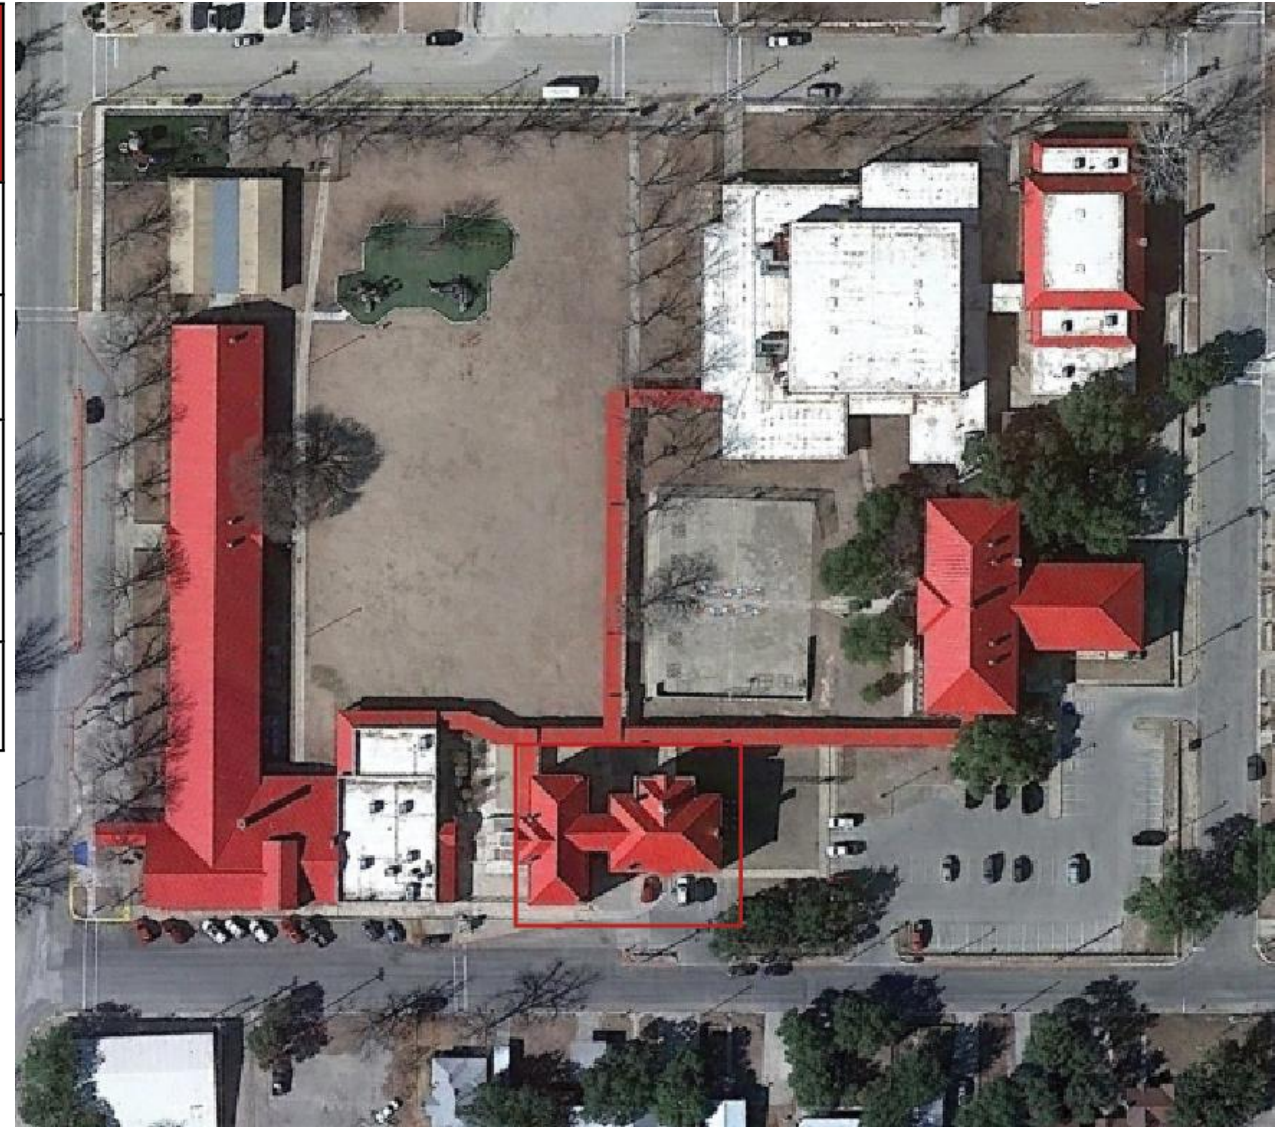
Rock Building
907 S. Concho Avenue
Sonora, TX 76950

Year Built	1904 2003-2005 renovation
Approx. Total Square Footage	21,948
Grades Served	Pre-K and 3
Current Enrollment	81
Building Levels	3

The Rock Schoolhouse Building is served by sixteen DX split-system heat pumps with auxiliary electric heat. All these systems are over 15 years old and use R-22 refrigerant. All systems should be replaced to eliminate the need for R-22 in future maintenance.

- Upgrade restrooms including all door hardware to meet current TAS/ADA requirements.
- Address fire risk issues in all electrical closets, classrooms, and corridors.
- Replace aging HVAC units to improve energy efficiency rating and avoid failure.*
- Upgrade finishes in each classroom for walls and floor surfaces.
- Add a protective awning near the drop-off area.
- Update furniture
- Add a backup generator
- Add keycard access to interior doors

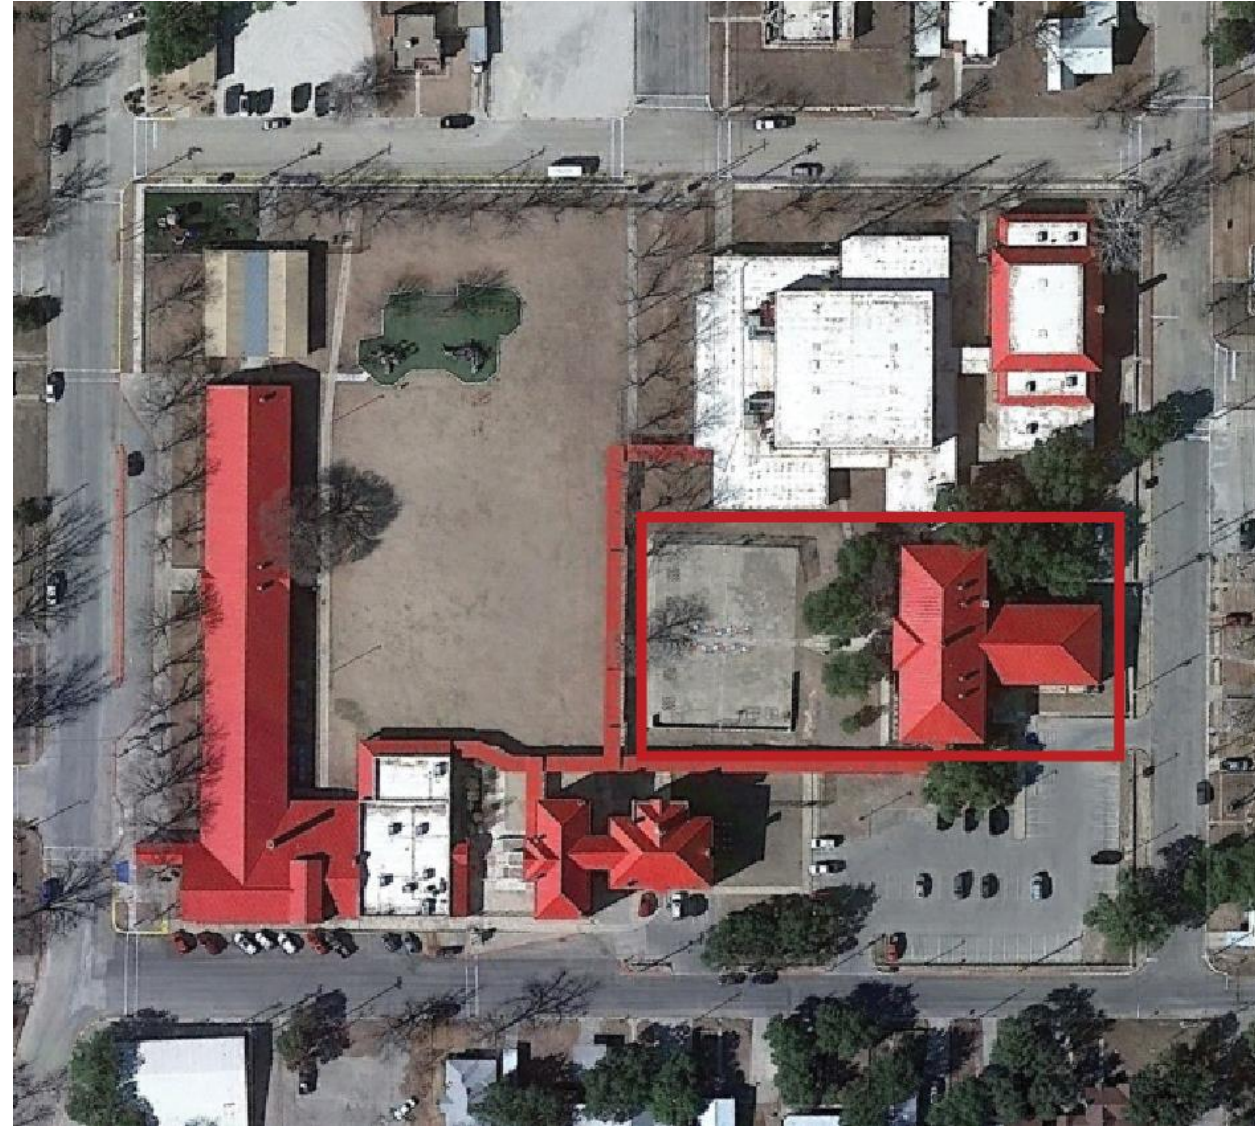
Intermediate School
907 S. Concho Avenue
Sonora, TX 76950

Year Built	1930 2003-2005 renovated
Approx. Total Square Footage	60,610
Grades Served	4-6
Current Enrollment	139
Building Levels	2

Building is served by a combination of DX rooftop units and split-systems. There are twenty-four DX split-systems with a mix of auxiliary electric heat and natural gas, along with twelve DX packaged systems with natural-gas heat. Thirty of these systems are aged 15 years or more and should be replaced. Eight of these systems (AC-1; HP-7; Coach's Office Mini-Split; RTU-1G; RTU-2G; Unit-5a/b; and Unit-6a/b) have been replaced in the last 15 years, but only four have been converted to R-410a. Unit-5a/b and Unit-6a/b should be replaced to eliminate the need for R-22 in future maintenance.

- Upgrade restrooms including all door hardware to meet current TAS/ADA requirements.
- Address fire risk issues in all electrical closets, classrooms, and corridors.
- Replace aging HVAC units to improve energy efficiency rating and avoid failure.*
- Upgrade finishes in each classroom for walls and floor surfaces.
- Inadequate electrical
- Backup power (computer closets)
- Update sound and lighting at Auditorium
- Add keycard access to interior doors

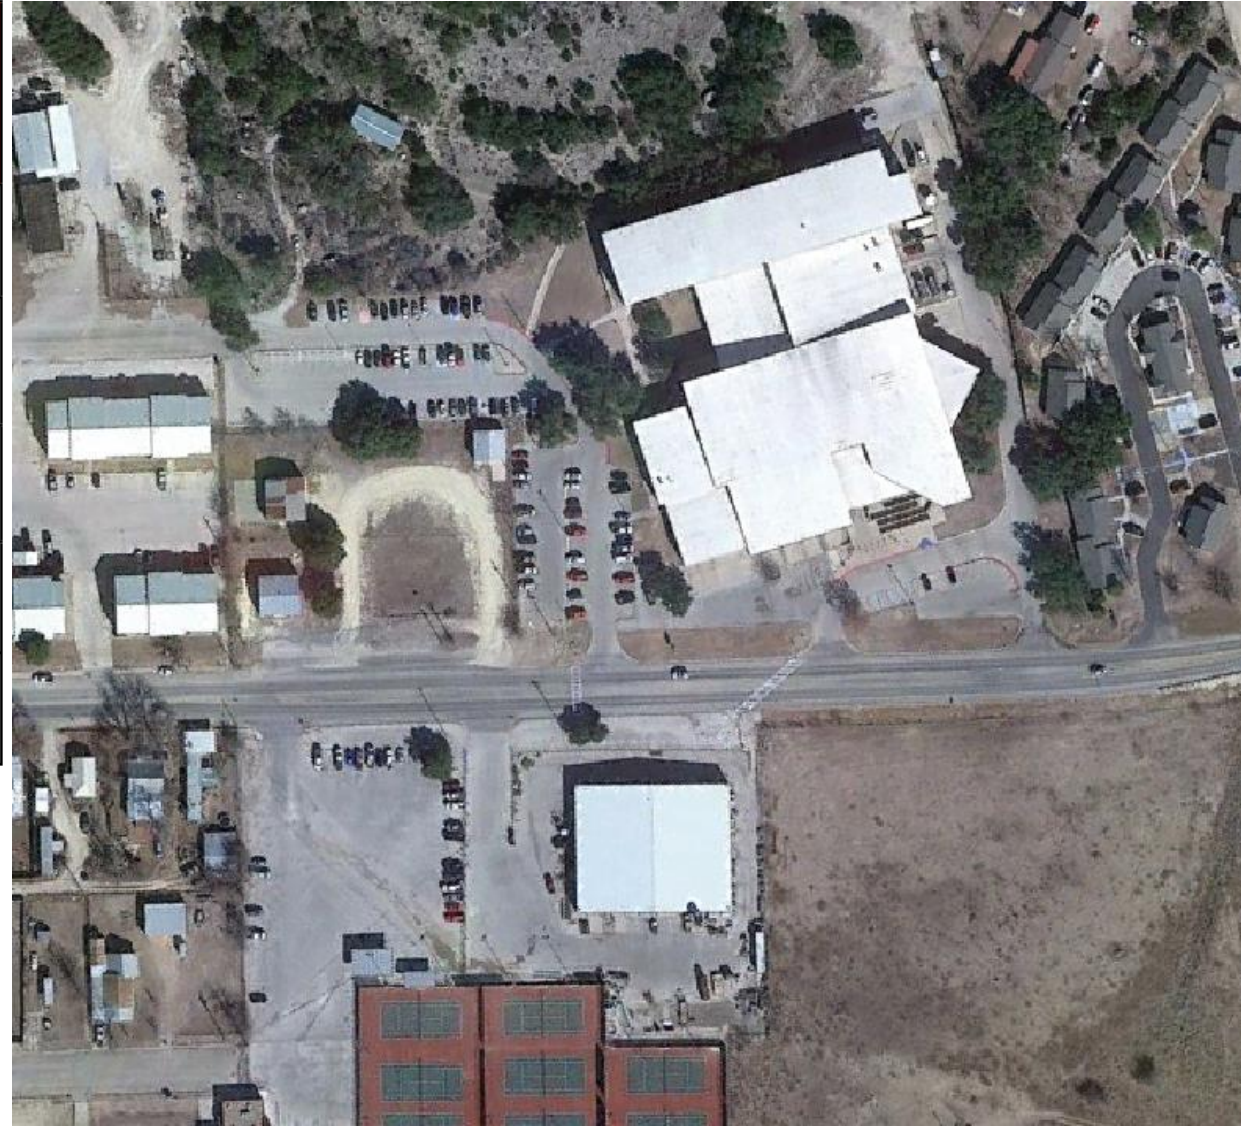
TAS/ADA

Inadequate Plumbing

Evidence of Moisture Damage

A central Chiller/Boiler Plant provides and circulates chilled and heating water through hydronic coils in semi-custom air handlers installed in mechanical rooms and mezzanines throughout the building. The boilers and boiler pumps have recently been replaced (Feb. 2019) and are in good working condition. The two 80 ton air-cooled chillers have both been replaced since the original installation, one in 2003 and the other in 2010. The 2003 replacement has reached the end of its expected life along with the chilled water pumps and should be replaced. The air handling units (AHUs) are low pressure, single zone McQuay AHUs manufactured in January of 1986. They have reached the end of their expected life and need to be replaced. Additionally, the piping/valve packages on the branch piping to each AHU show signs of failure and should be replaced. A full air and water side TAB should be performed before principal design begins for a whole building project like this to establish baseline operational parameters for the post construction TAB. A commercial style 7.5 ton Trane split-system is also installed in the chiller yard. It was manufactured in July of 2002 and has reached the end of its expected life.

- Repave all asphalt parking lots and repaint all pavement markings
- Install crosswalks to improve safety
- Replace carpet in all areas
- Repaint all interior classrooms and corridors
- Replace hardware and restroom partitions
- Upgrade restrooms to meet current TAS/ADA requirements
- Upgrade lighting in the auditorium
- Increase parking lot capacity

- Define visitor parking spaces
- Replace aging HVAC units to improve energy efficiency rating and avoid failure.*
- Add outdoor PE area for 7th & 8th grades
- Add moisture barrier / correct moisture barrier at HS commons
- Add keycard access to interior doors
- Convert HS locker areas to commons
- Inadequate electrical
- Backup power (computer closets)

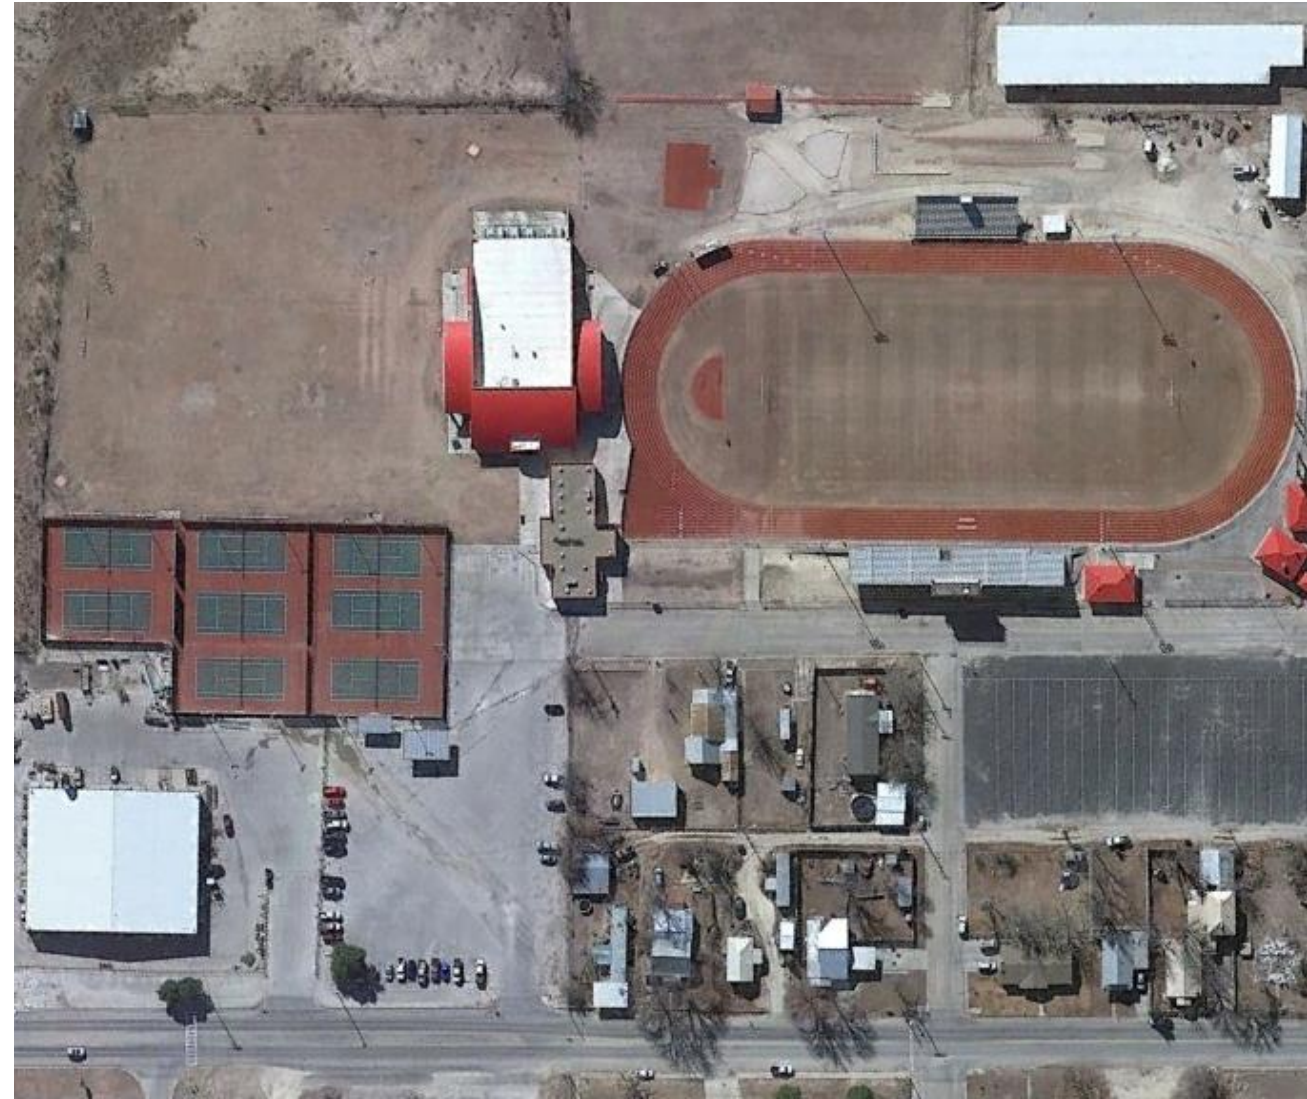
Athletics

- The lighting in the gymnasium needs to be upgraded. Continue to maintain the athletic fields to be in premium condition.

Inadequate lighting
